**SLEDDALL HALL
WILDMAN STREET
KENDAL
CUMBRIA**

TREE-RING ANALYSIS OF TIMBERS

SLEDDALL HALL, WILDMAN STREET, KENDAL, CUMBRIA; TREE-RING ANALYSIS OF TIMBERS

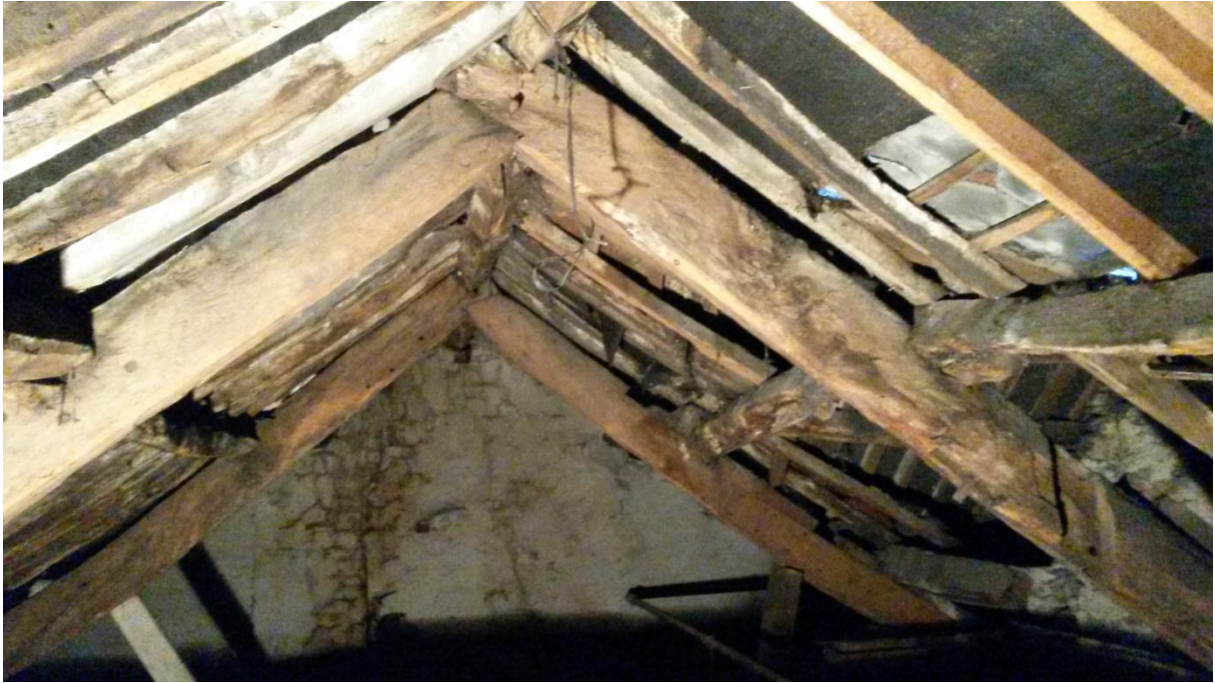
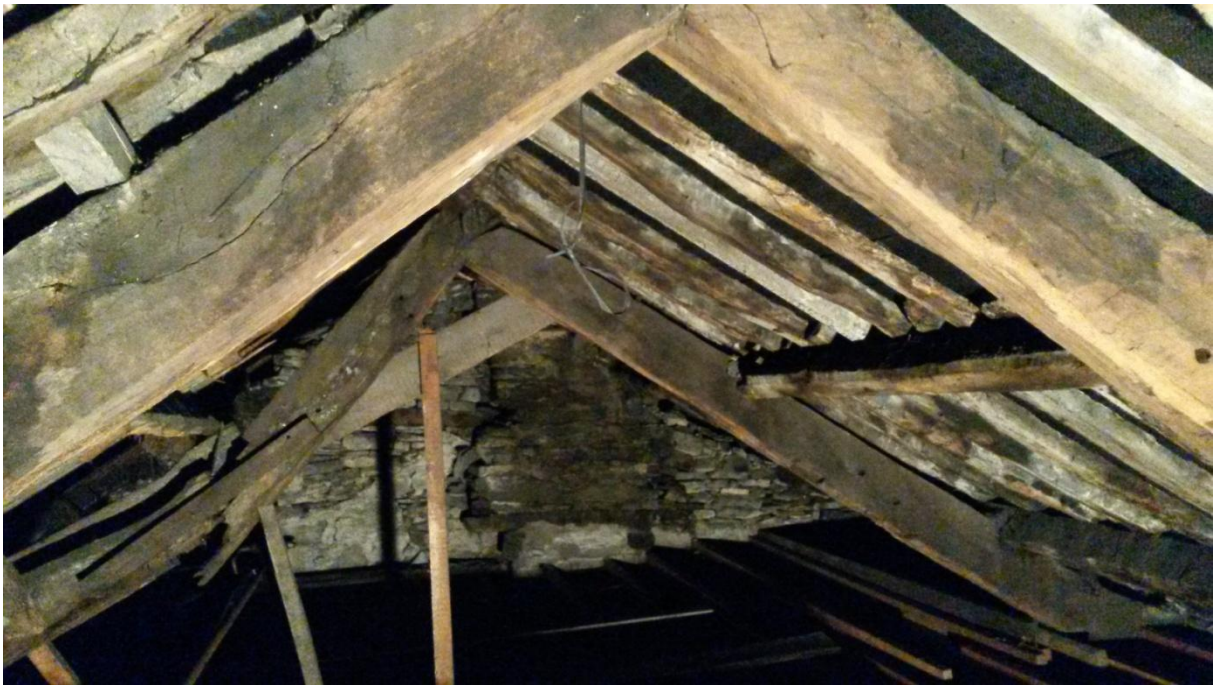
Figure 3a/b: Views of the front range roof, looking west to east (top) with truss 2 in the foreground and truss 1 beyond, and looking east to west (bottom), with truss 3 beyond

The roof to the front range comprises three principal rafter-with-tiebeam trusses, the principals supporting double purlins to each pitch, the purlins in turn supporting common rafters (Fig 3a/b). Some of the joints to this timbering are slightly ill-fitting and there are also some redundant mortices and peg-holes. Some of the timbers, particularly the purlins, are also of slightly different sizes. However, while it is possible that some older timber has been reused here, and/or that some more recent timber has been introduced as later repairs, it would seem that a substantial number of the roof timbers are original, although there may have been some re-setting of these timbers.

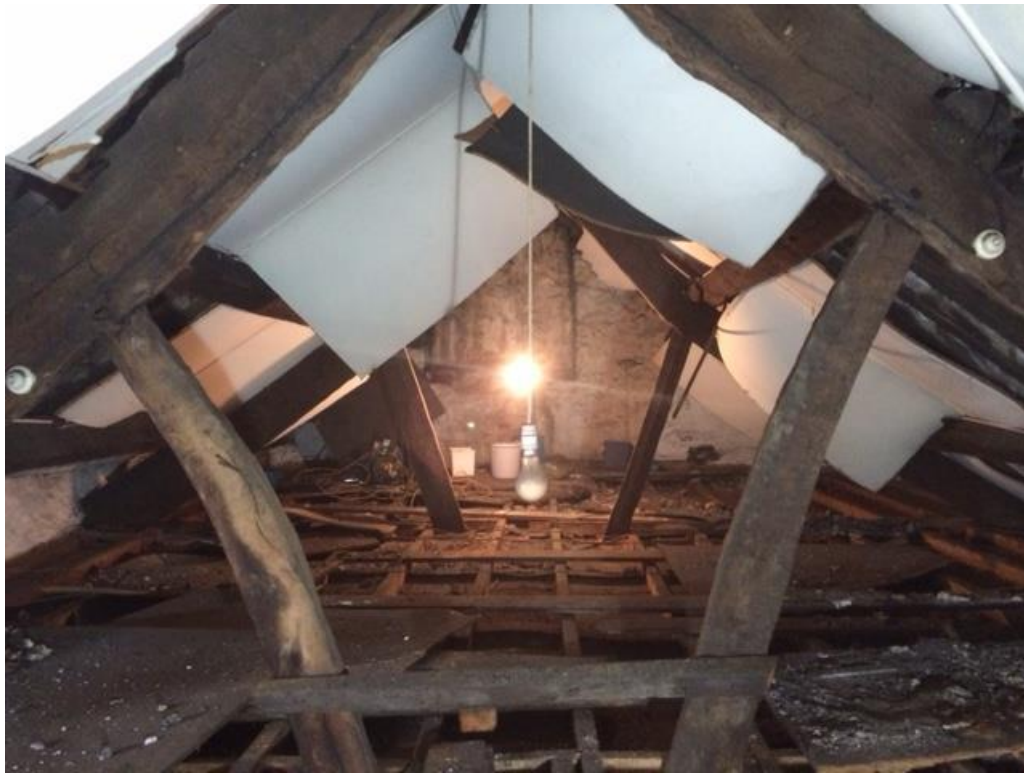
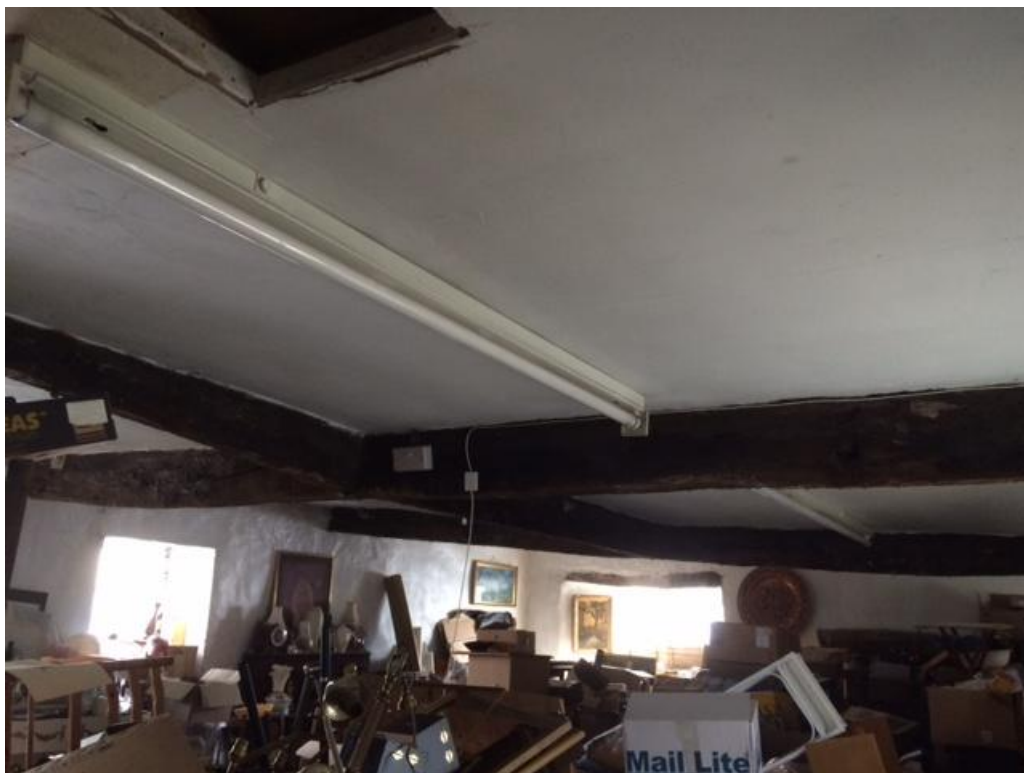
Figure 3c/d: Views of the rear range roof, looking north to south (top) with truss 5 in the foreground and truss 6 beyond, and the first floor ceiling to the rear range (bottom)

The roof to the rear range also comprises three principal rafter-with-tiebeam trusses, the principals again supporting double purlins, which again support common rafters. In this roof, however, not only are there both slightly curved and straight queen struts to the trusses, but the timbers (apart from some purlins which are clearly modern replacements), all appear to be of similar dimensions and they have a much more consistent appearance than do the timbers of the front range roof (Fig 3c/d).

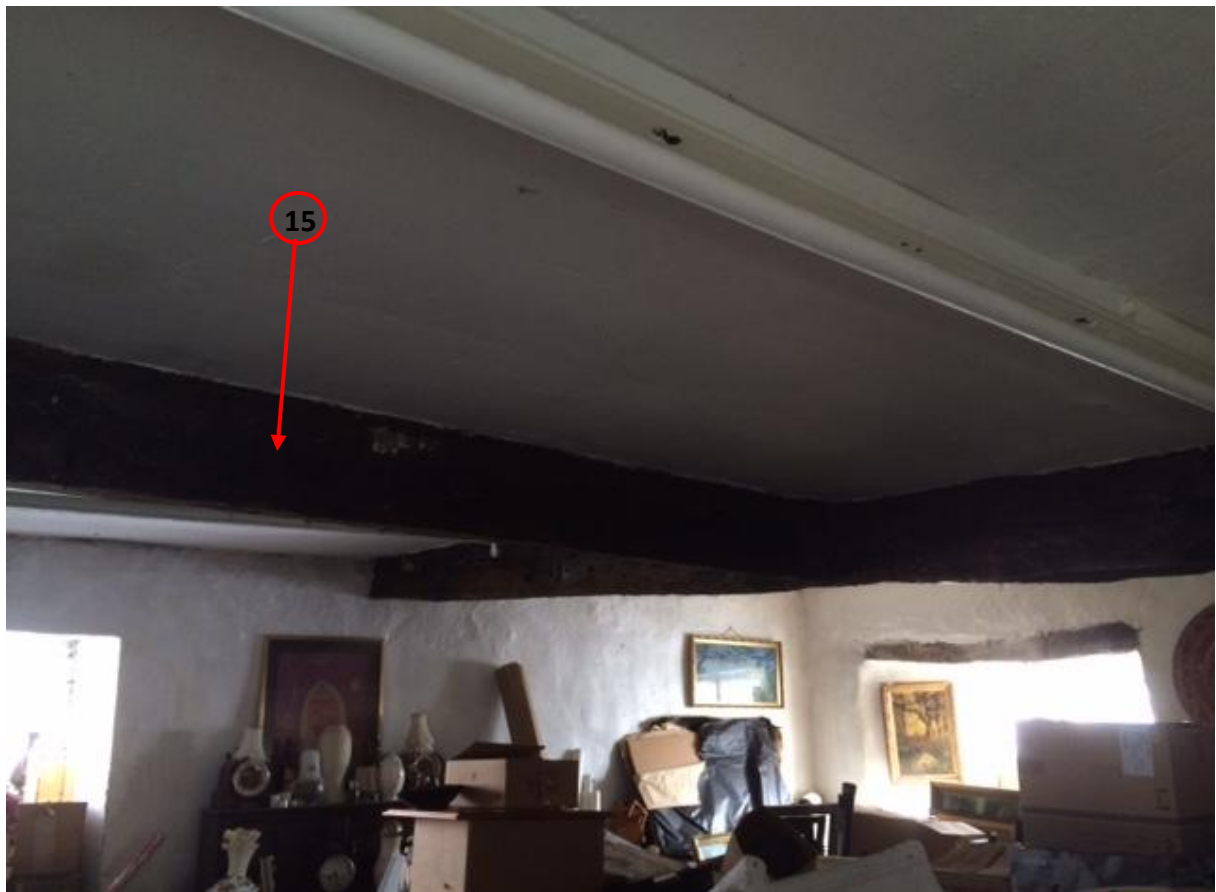
Figure 4g: Annotated photograph of the first floor ceiling to the rear range to show sampled timber (see Table 1)

Thus, from the timbers available to the roof and floor frames of both the front and rear ranges, a total of 15 samples was obtained by coring. Each sample was given the tree-ring code KND-A (for Kendall, site 'A'), and numbered 01–15. Details of the samples are given in Table 1, including the timber sampled and its location, the total number of rings each sample has, and how many of these, if any, are sapwood rings. The individual date span of each dated sample is also given. The sampled timbers are located either on drawings taken from the Cumbria Vernacular Buildings Group survey report or on annotated photographs, these being shown here as Figures 4a–g. In this report the front of the building is taken to be facing 'site north' onto Wildman Street.
