‘Sleddall Hall’ Wildman Street, Kendal.

Cumbria Vernacular Buildings Group (CVBG)

A survey undertaken by Clive Bowd & Mark Basey-Fisher 2015

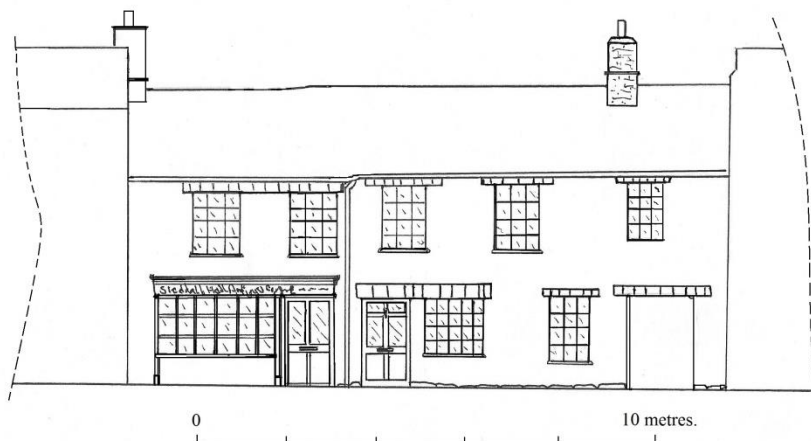
Fig. 1: The north elevation

Sleddall Hall, Wildman Street, Kendal.
North elevation drawing. Scale 1:100.
Clive R. Bowd. CVBG. 24/09/15.

The main elevation of the building as we see it today faces north onto Wildman Street, a busy access road into Kendal, thereby providing passing trade. This north elevation is set back from the properties either side (which dwarf it), and comprises of random rubble mass walling utilising the local stone available, mainly limestone and various odd stones that have come from the glacial till. There is a slight difference in the size and construction of the stone to the left hand two bays, some coursing being evident. Portland cement appears to have been used in re-pointing the stonework. The frontage is five bays with four equal sized and spaced sash windows (minus horns) with twelve panes apiece on the first floor with a fifth fixed,

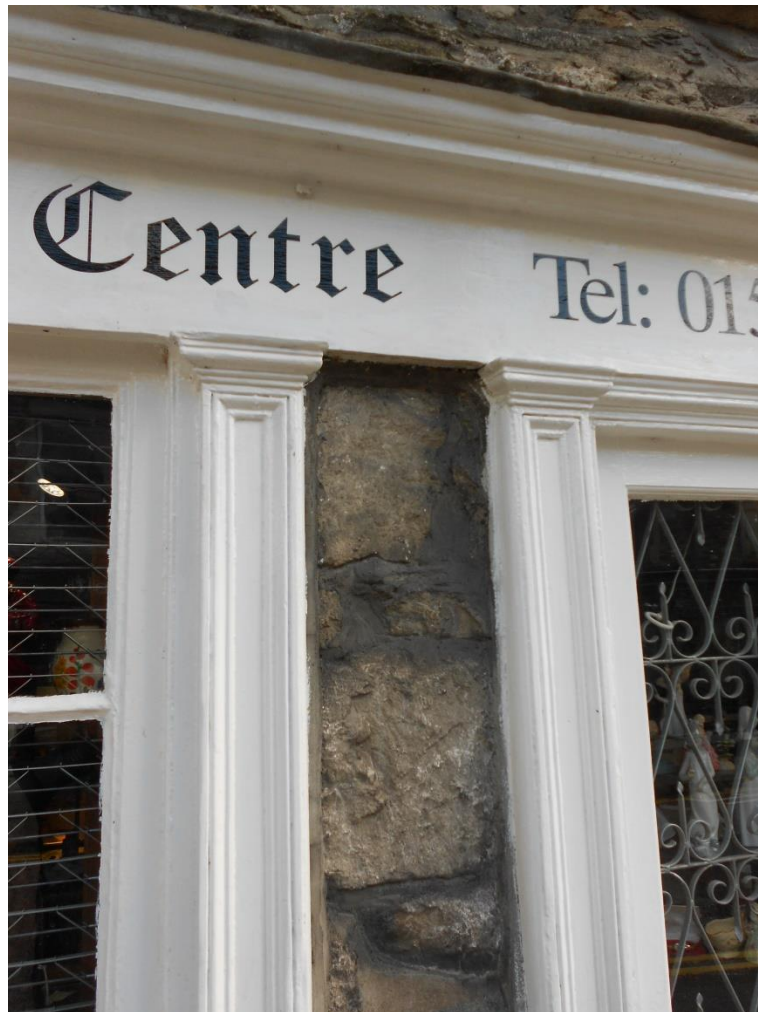
Plate2: Detail of timber fascia and moulding to window & door.

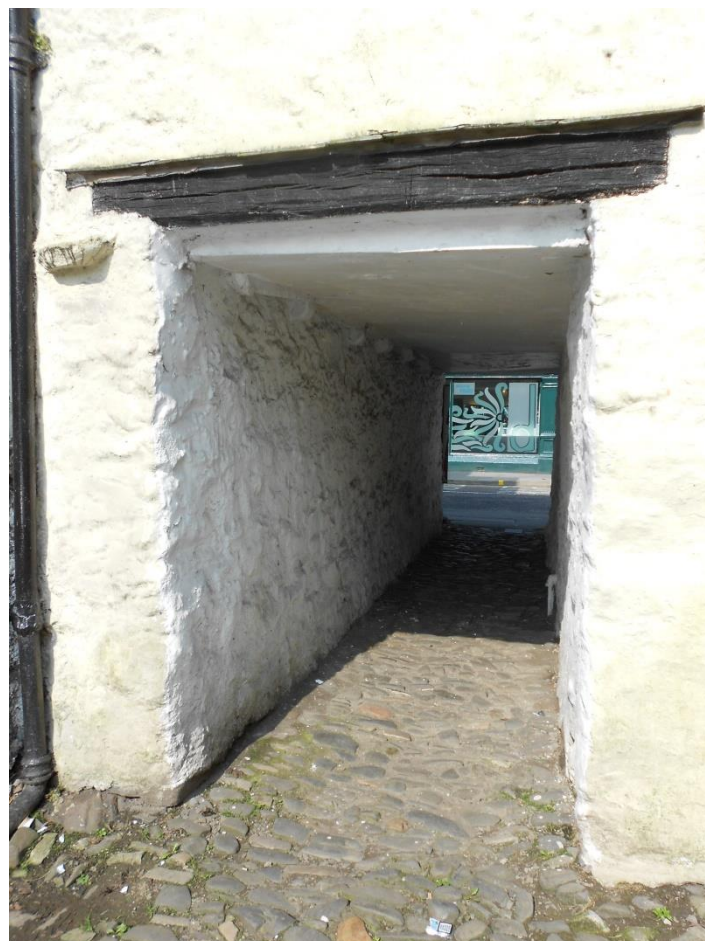
The ginnel (see plate 3 below) walls are lime-washed, the stone beneath showing through as undulating surfaces, again, made up of random rubble. The floor surface was comprised of waterworn cobbles set in sand and grit, much the same as the cobbled yard, (this having been excavated and washed out by the flooding caused by Storm Desmond in December 2015, salvaged and awaiting relaying). This event allowed close inspection of the footings, which like the front elevation, comprises of a boulder plinth set directly on the glacial till. These boulders are set no more than an average of 15cms into the substrate and take the full loading of the building, the walls being built of an inner and outer skin filled with rubble with no through stones evident. Set into the western side of the ginnel is a row of roughly chamfered stone corbels supporting the floor above. There are no openings or other features to be seen in the ginnel, except for a shallow rebate at its north-east end, the ceiling being modern and encapsulating the floor joists above.

Plate 3: The ginnel looking north, prior to damage caused by Storm Desmond. Note the stone corbels.

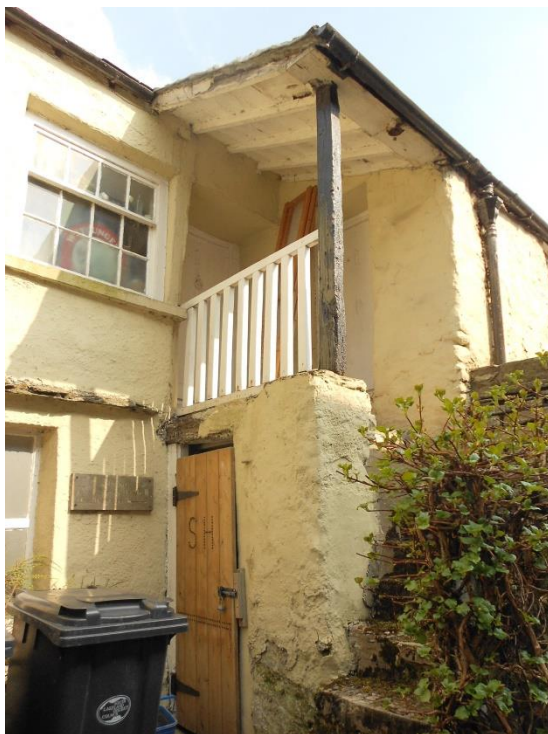
Plate5: The access stair.

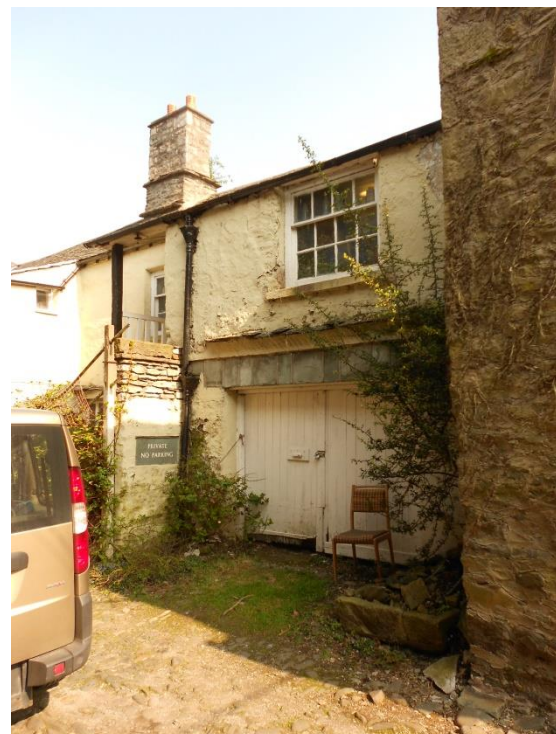
Plate6: The garage doors.

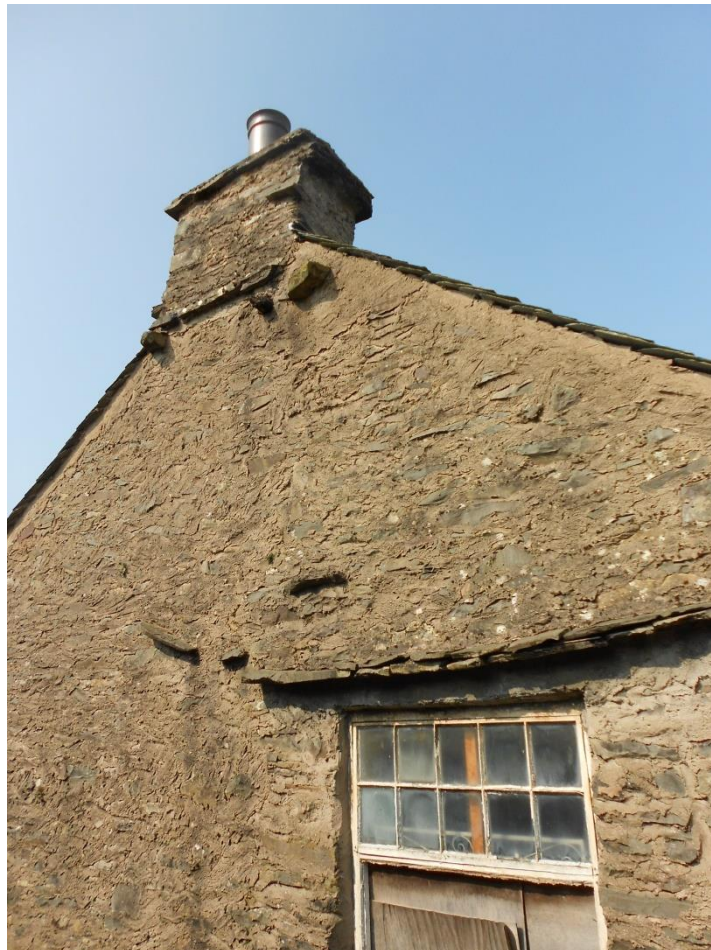
Plate7: The south elevation gable showing the reduced upper window, drip mould and chimney.

The south gable (see fig. 7 above) of the southern range presents a blank face almost, the stone of the random rubble wall being crudely pointed up, more akin to Scottish harling. Just two windows give its austere finish any interest. The upper window is located top right and is of twenty panes, five wide, the upper ten forming a casement. But this is not its original size,

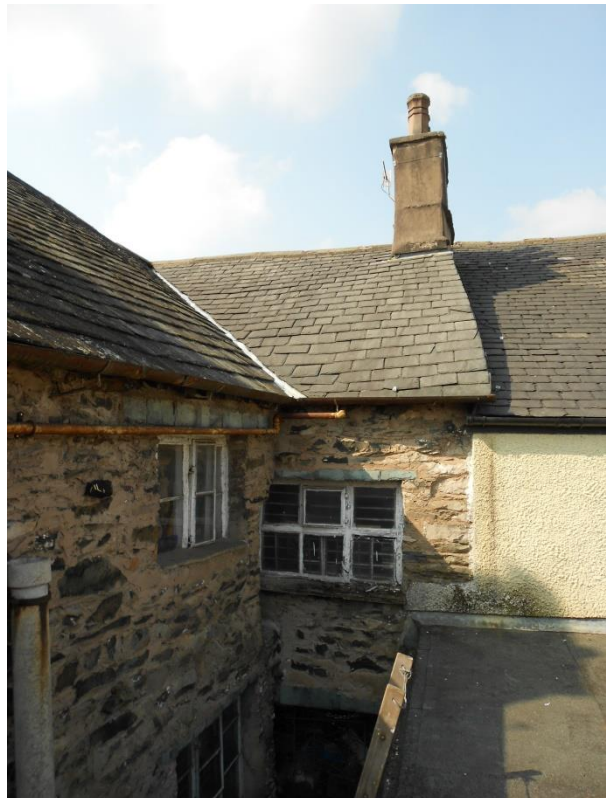
Plate8: The east elevation of the south range where it meets the north range. Note the chamfered corner with the two south facing windows tucked into the return.

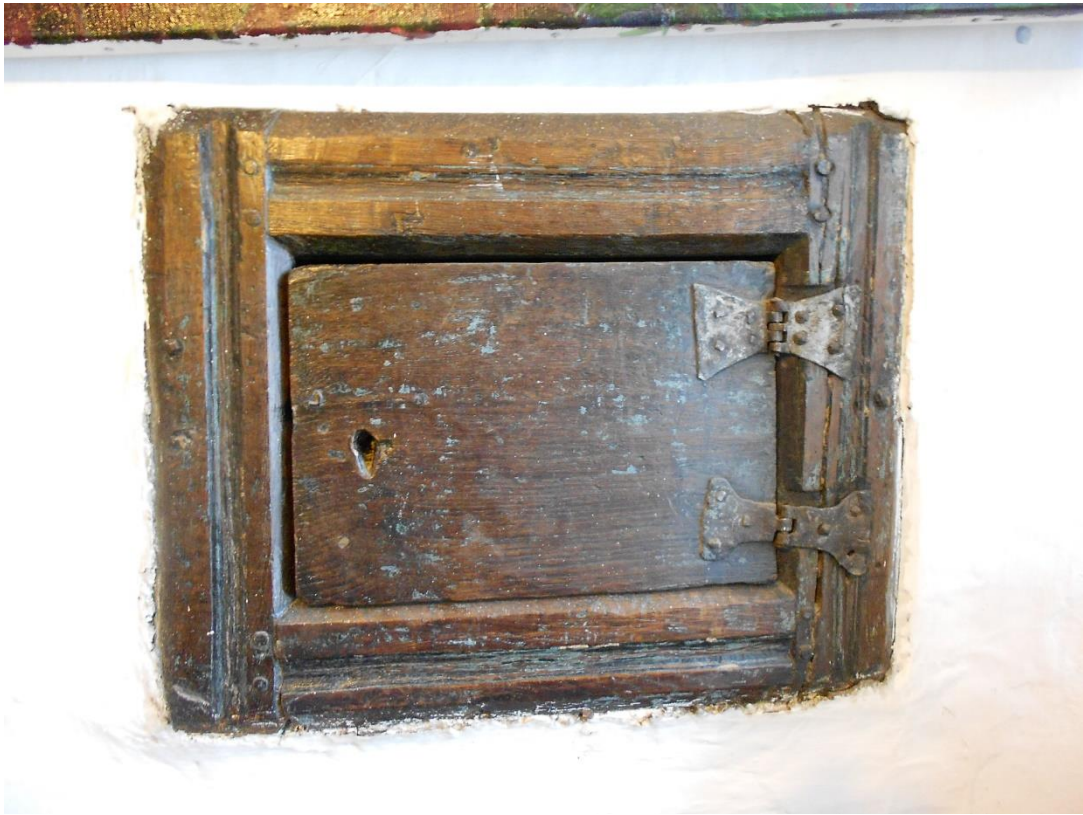
Plate10: The spice cupboard. Note the non-matching butterfly hinges.

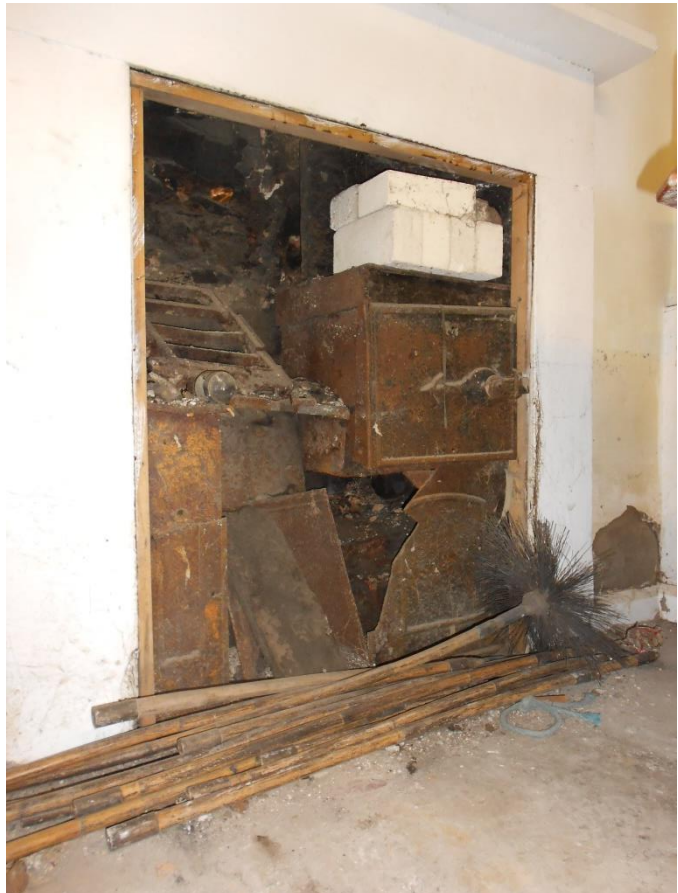
Plate 11: The broken hob-grate in G4.

their properties? Here then is a possible connection with the power and influence built up by the Fisher's over time, but more research is needed to confirm, or otherwise. The surviving grate within the fireplace in G4 (although badly damaged), is a simple cast-iron hob incorporating an oven to the right and sham plate on the left, designed for burning coal. Whilst an exact date of manufacture has not been ascertained, a date in the last decade of the 18th century would appear to be about right. This last action will have made a better impression on visitors and clients who could then have entered the office by the front door off Wildman Street via what was effectively now a through passage, having been formed by the insertion of another timber partition, or possibly a screen, closing off the firehouse, the feint groove in the flag-stoned floor suggesting such a change took place.

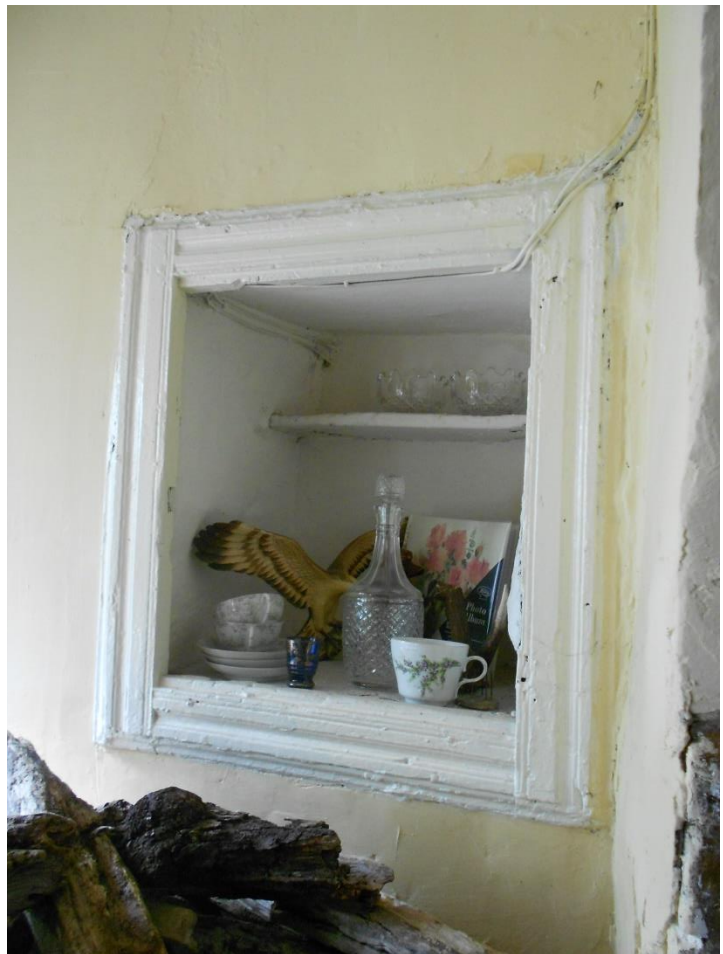
Plate12: The spice cupboard in G7.

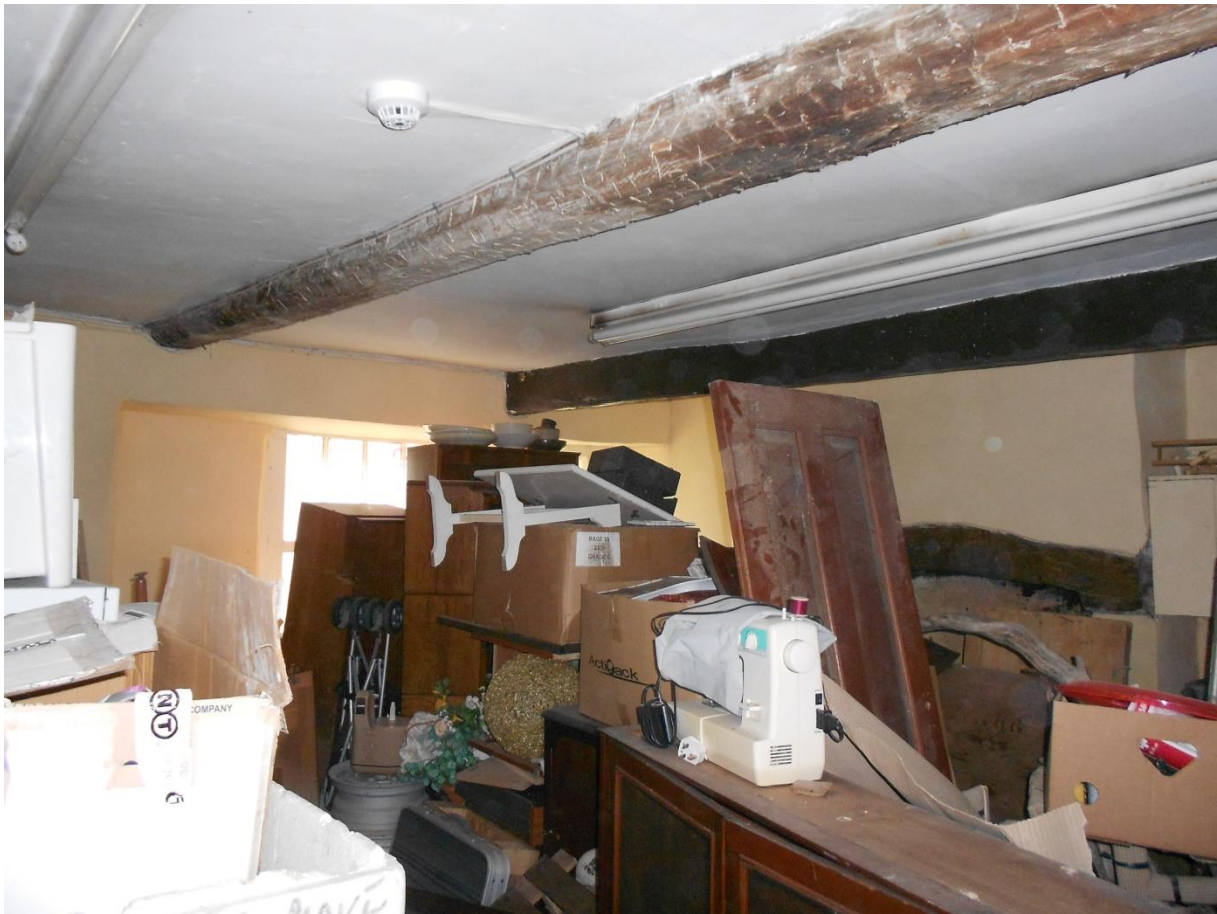
Plate13: G7: showing the central hacked joist, the lintel of the fireplace and the reduced window.

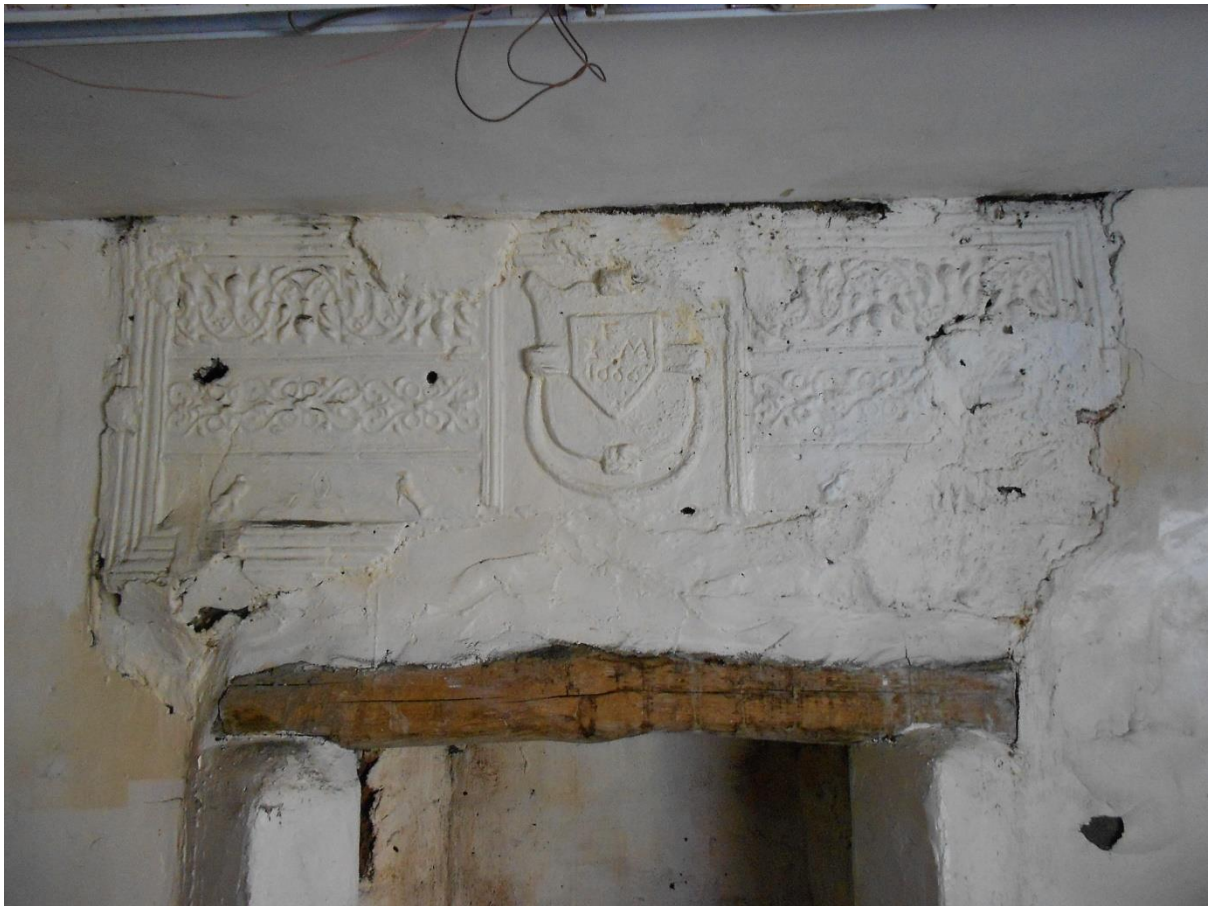
G8 The larger store and the plastered dated overmantel. This area is accessed from the modern garage doors in the cobbled yard, the opening having been reduced. Another opening opposite gives access to the former kiln area. The south east corner of this area has been partitioned off to form a toilet and kitchen area, itself lit by a window with a plain chamfered mullioned frame in the east wall, and a modern window in the south wall, this being set into a semi blocked door aperture. Access issues again made survey difficult. Set flush into the south wall, but offset, is a fireplace, the rustic timber lintel supported on diagonal pillars of brick set slightly forward of the wall. This lintel in turn supports another heavy (fire charred) timber lintel. Above this is a damaged plaster panel overmantel, apparently in situ (see plate 14). The horizontal panel (measuring some 130cms. x 60cms. approx.) has four ribbed lines

forming a border within which it is divided up into three sections by a central shield containing the inscription F over IM over the date 1666, itself enclosed in a larger shield shaped like cartouche. To right and left are three registers containing different designs, the upper has what look like acorns and bulbs with leaves and a linear linked cyma recta running through all, the centre is made up of scrolled hearts on their sides, back to back, with four linked circles between more acorns? The bottom register has two standing birds, a hawk and a martlet on either side of a fleur de ley on the left and another fleur de ley on the right, but this time with what appear to be a sitting mouse and possibly a sitting lion either side. All is covered in a heavy white lime-wash, or emulsion, making identification of the animals somewhat difficult. Within the plastered fireplace on either side, facing into the fire, are two vertical keeper holes. The ceiling is plastered, the floor concrete.

Plate 14: Decorated plaster overmantel dated 1666 and carrying the initials F over IM.

Of course, adding to these conflicting observations is the presence of the dated plaster overmantel of 1666, which appears to be in situ and therefore tends to rule out the barn theory. But the overmantel cannot be ignored, so failing any other datable features it should form the basis of the dating for the south range. Such an overmantel is usually to be found over the principal fireplace in a house of the period, or at the very least, acting as a secondary feature in a public room in a house with some status. This really brings us back to its location, on the ground floor built into the south gable of G8. With no reason to believe otherwise, this fireplace, together with that above in F5, would seem to be part of the original build of the south gable wall, both flush with the wall suggesting a two storey building at conception. How then do we equate this with the former open hearths at the opposite end of the range in G7 and G5? All may well be of the same date, if we take into account the *Hearth Tax Return* of 1670, the number of hearths would indeed add up to that recorded, four. This calculation allows for ground-floor hearths only, as at this period there was no second storey on the front north range and going by the construction of the back-to-back fireplaces, these too only served ground-floor rooms. The upper fireplace in F5 will most likely have gone undetected, perhaps a perk of being a person of standing?

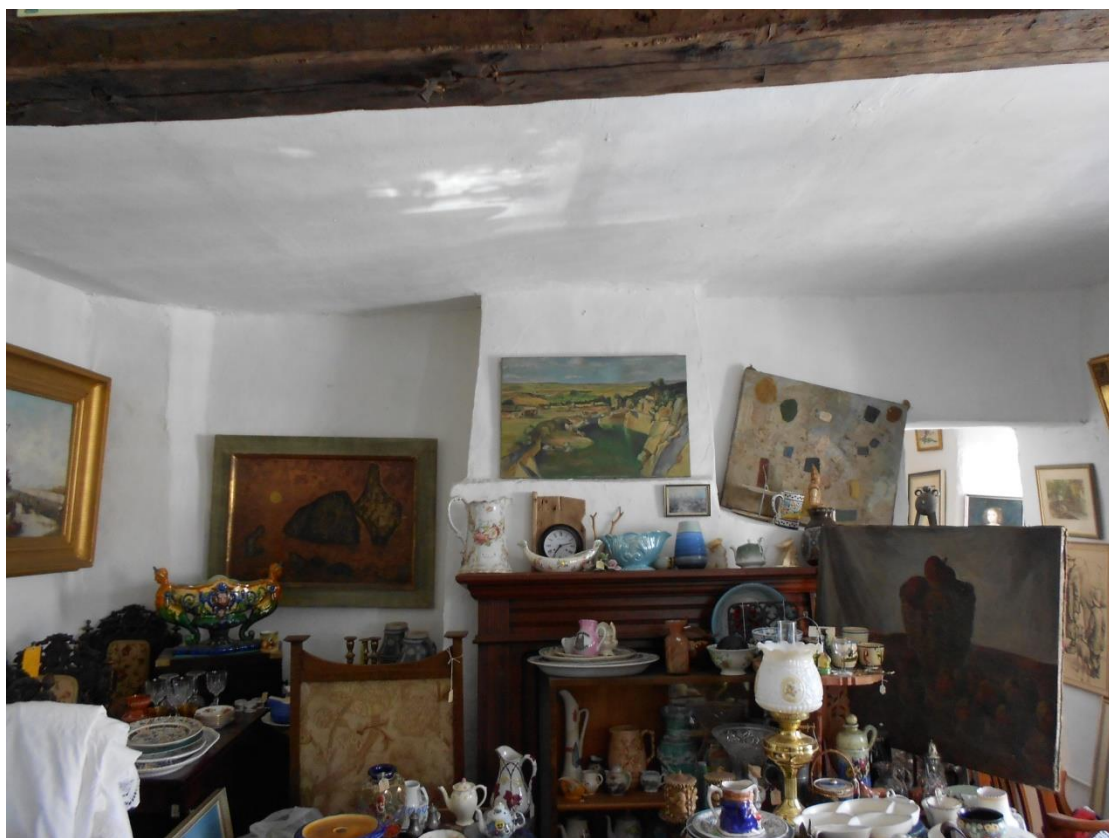
Plate15: F13 looking west to the chimney stack. Note the attached flue on the right.

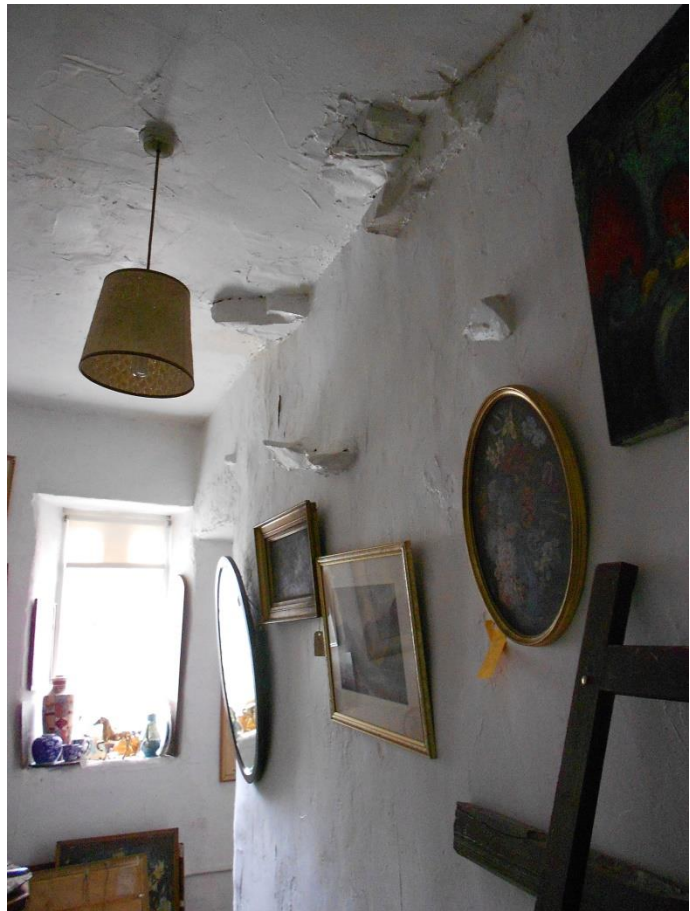
Plate16: Detail of the through-stones and corbels to be seen in F3.

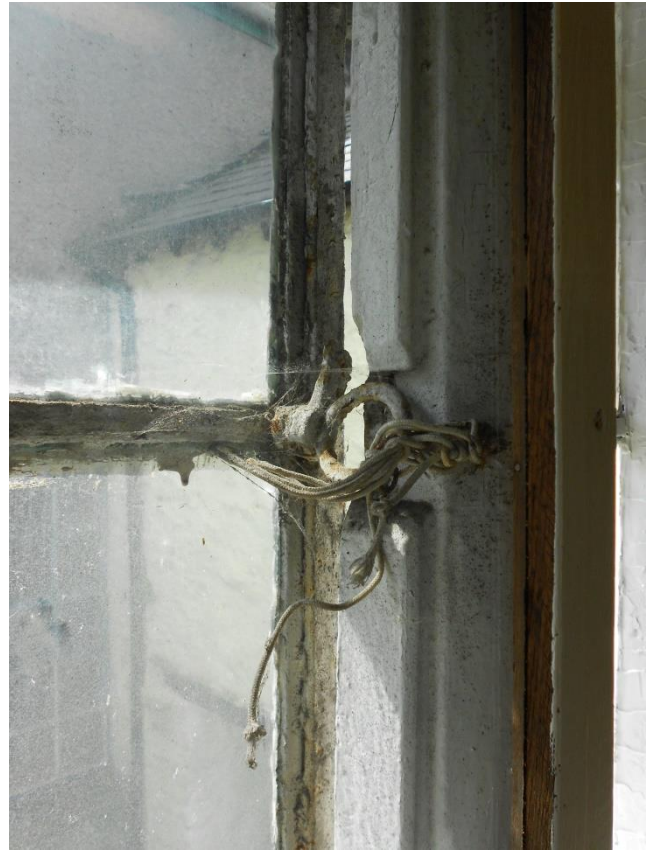
Plate17: Detail of an iron window catch in F4.

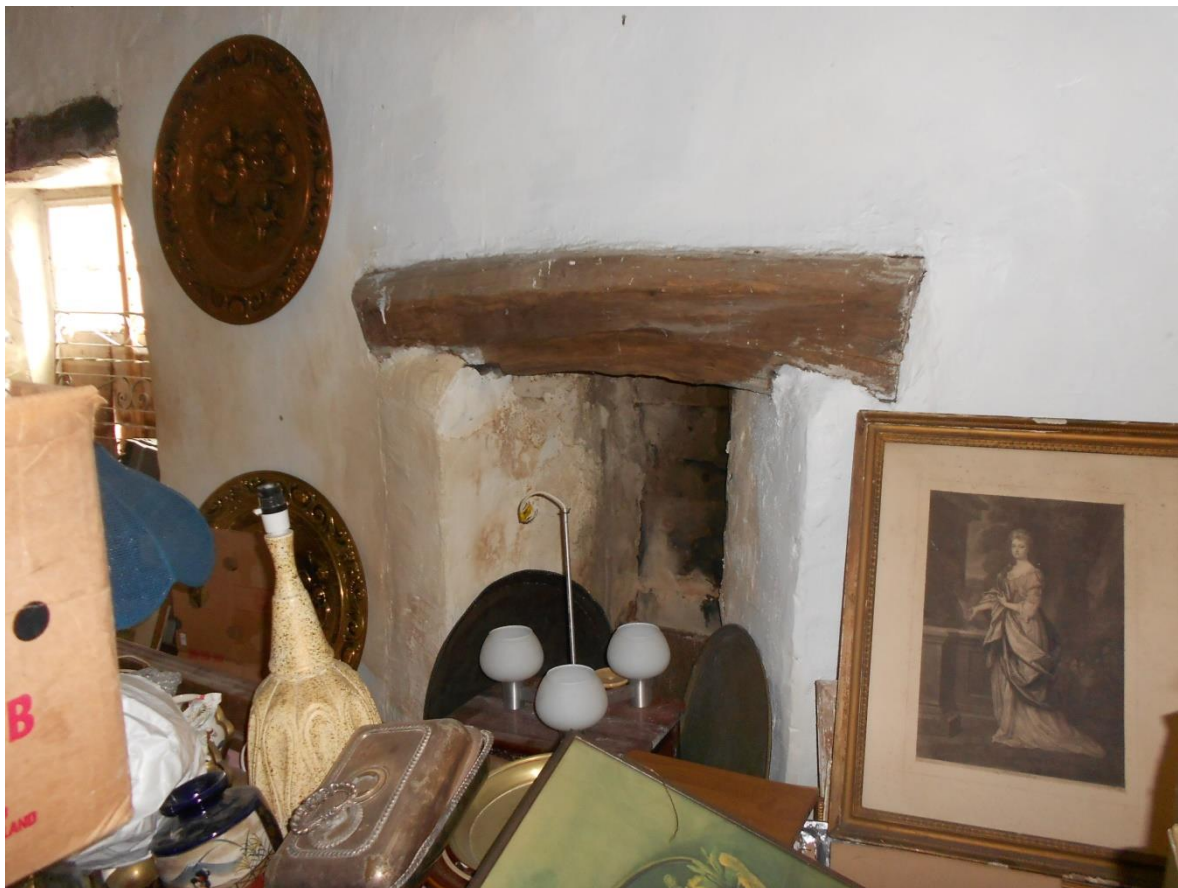
Plate18: The 'restored' southern fireplace and gable window.

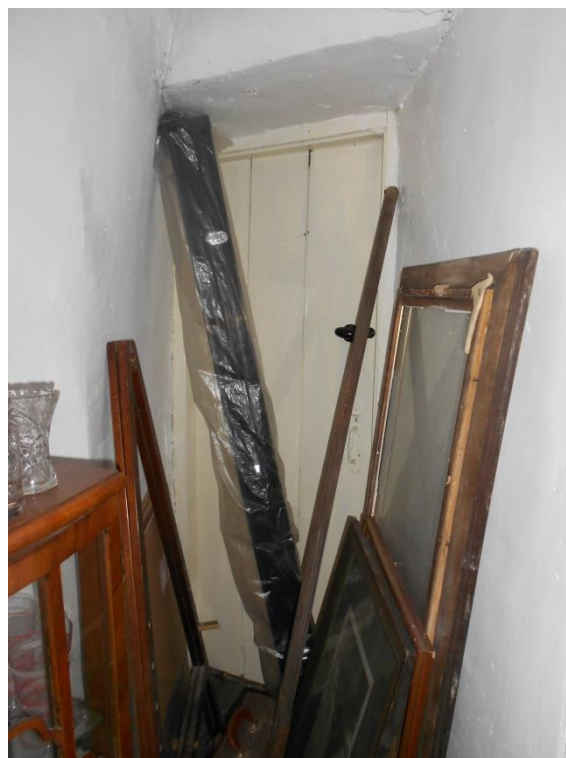
Plate19: The door within the inserted 'squint' passage to the left of the blocked north fireplace.

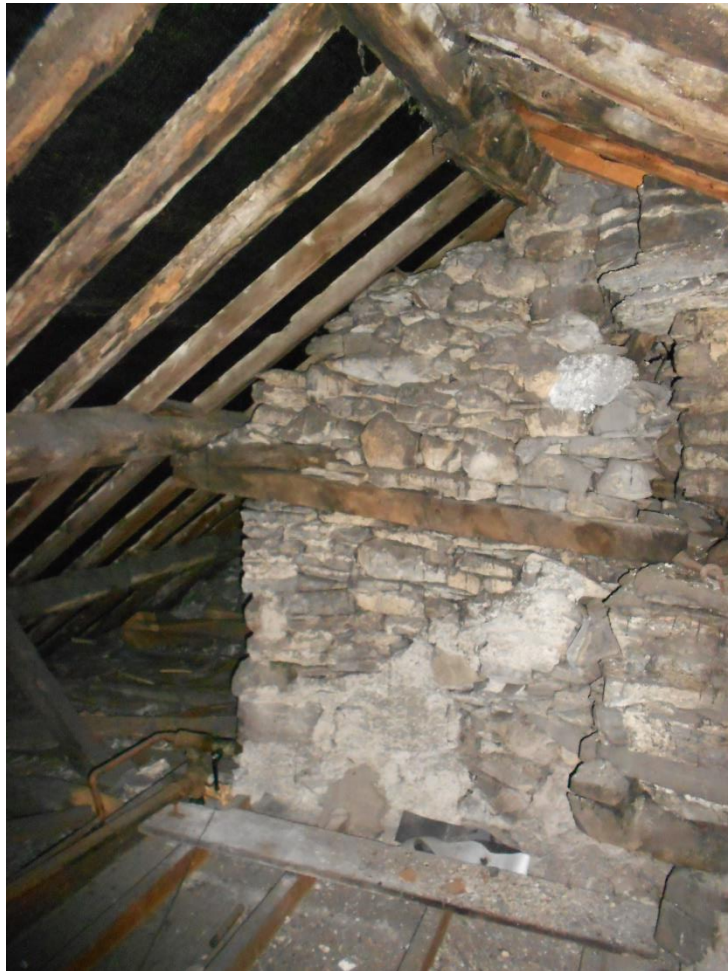
Plate20: The north range loft showing the heightened western chimney stack.

The north loft extends as an open loft over the entire north range, only being divided at the west end by the chimney stack that forms a partial barrier to free passage throughout (plate 20). The floor is not boarded and there is no electric light or skylights, making movement difficult. A noticeable change in levels can be observed at the access point, the hatch in the ceiling on the landing between F1 and F2. This level difference is due to the ceilings below being secured in different ways with that over F2 being suspended and tied into the stud partition walls that divide this area into two. The tops of these partitions can be seen held in place by timber pegs. The ceiling area over F1 has been mainly renewed using machine cut joists and plasterboard. Within the space over F3 vestiges of lath and plaster ceiling can be seen. Three simple trusses with tie beams, lapped and pegged at the apex are present. A heavy ridge purlin square in section, diagonally set, is complimented with two further rows of lapped purlins on each elevation carried on the backs of the trusses, let into rebates and

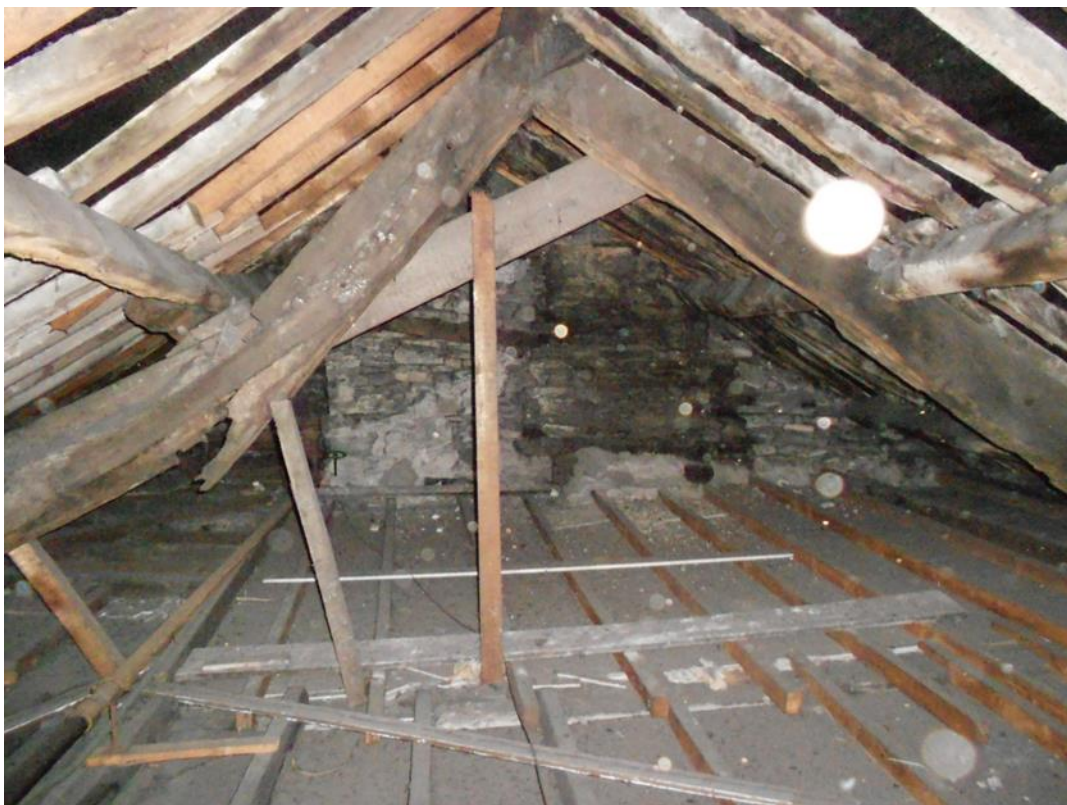
pegged with lapped rough cut rafters, (see figs. 2 & 3). The western chimney stack has been added to either side providing a supporting wall, doing away with the need for a further truss, thereby dividing the loft into five bays. The ridge purlin is supported at the east gable, where it runs into the wall, by a projecting beam acting as a corbel. The purlins are run directly into the gable walls. A catastrophic failure can be seen in the truss over F1 on its south aspect, this having been patched up and given further support during reroofing in recent years. Further repairs and strengthening can be seen in various places necessitating small bracing struts and props, also a section of steel plate! Behind the access hatch, the purlins at this point can be seen to have been cut through in order to extend the roof on the south range and marry up the two. A blocked access point utilising a crude frame along with lath and plaster (measuring 150cms high x 88cms wide), can be seen in the gable wall to the south range, this, like the west chimney stack, replacing the need for a truss. The western chimney stack (110cms in width), rises through the loft, timber corbels and beams supporting the load at ceiling level with a projecting drip course 33cms above this. The stack then continues up (100cms in width) 66cms before yet another drip course is encountered, just below the slope of the roof. The two drip courses average 10cms deep, the upper one extending all around the stack, the lower one having the western section omitted. The ghost of a former roofline can be seen on the eastern elevation whilst a diagonal recess in the west elevation suggests projecting eaves supporting a bargeboard. Within the bay, formed by the extension of the roof beyond the western chimney stack, a spliced purlin can be seen, the join pegged with two lengthy treenails, this being done so as to extend the purlin. Another thing to note is the expansion of the roof at this point, a rafter clearly pulled away from the ridge purlin by approximately 10cms and exposing the treenail that formerly held it in place!

Plate21: The north range loft looking west, showing the failed principal rafter.

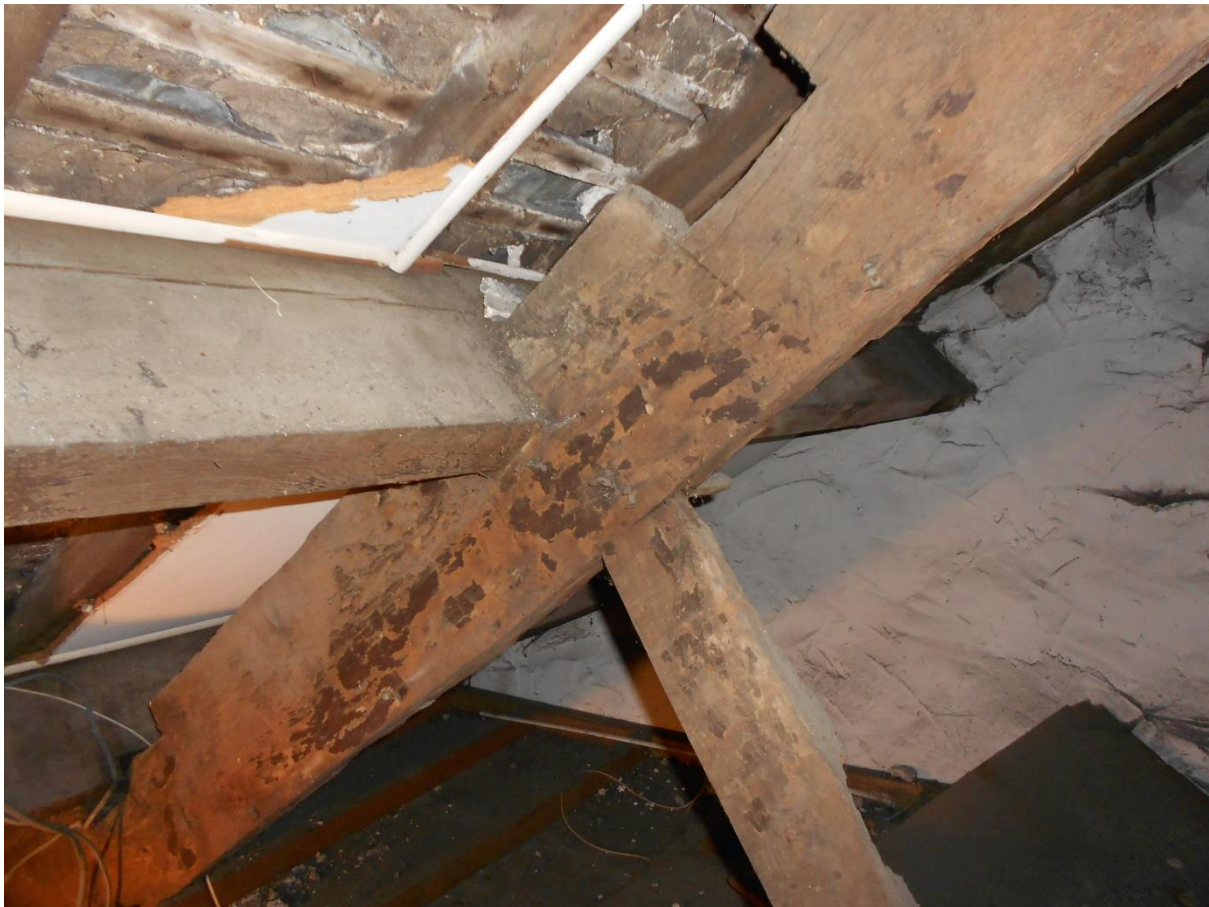
Plate22: Reset purlins in braced truss. Note the lime torching.

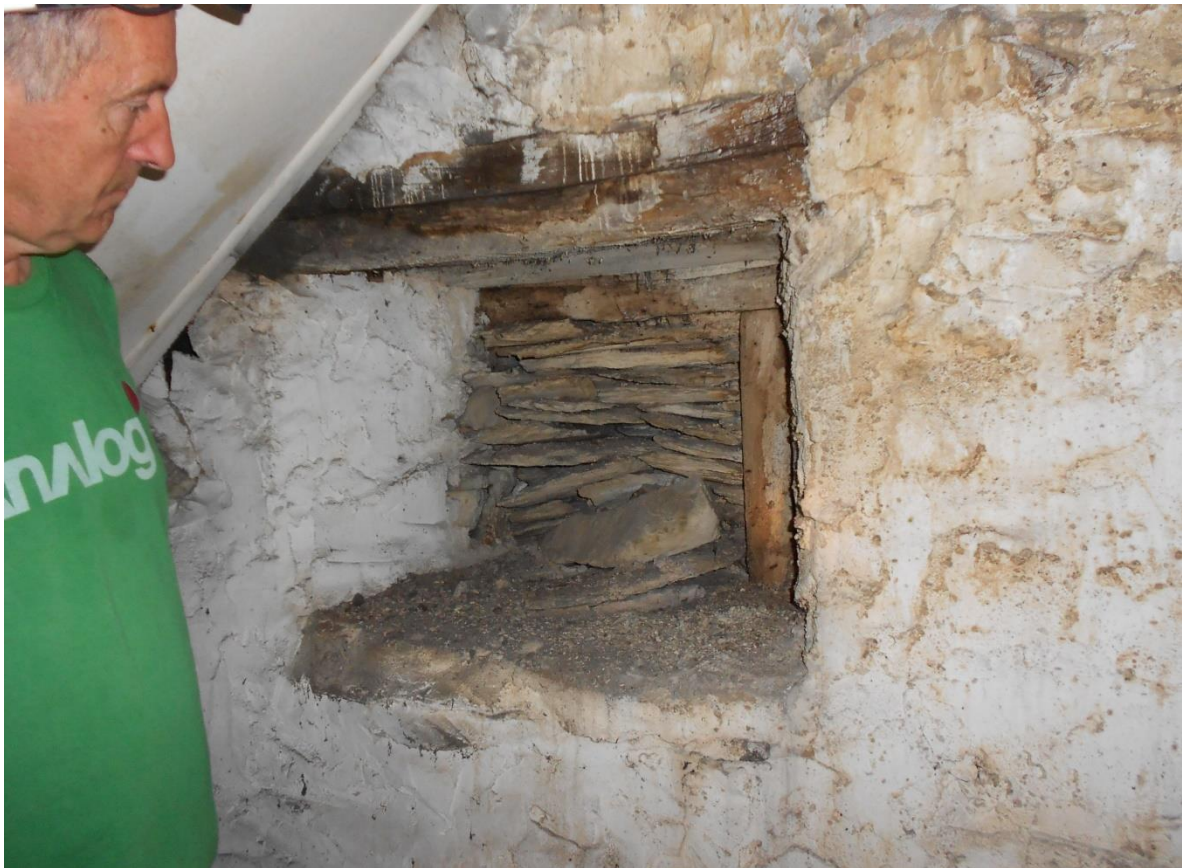
Plate23: The small, blocked, gable window. Note the reuse of old roofing slates, the timber frame and lintels.

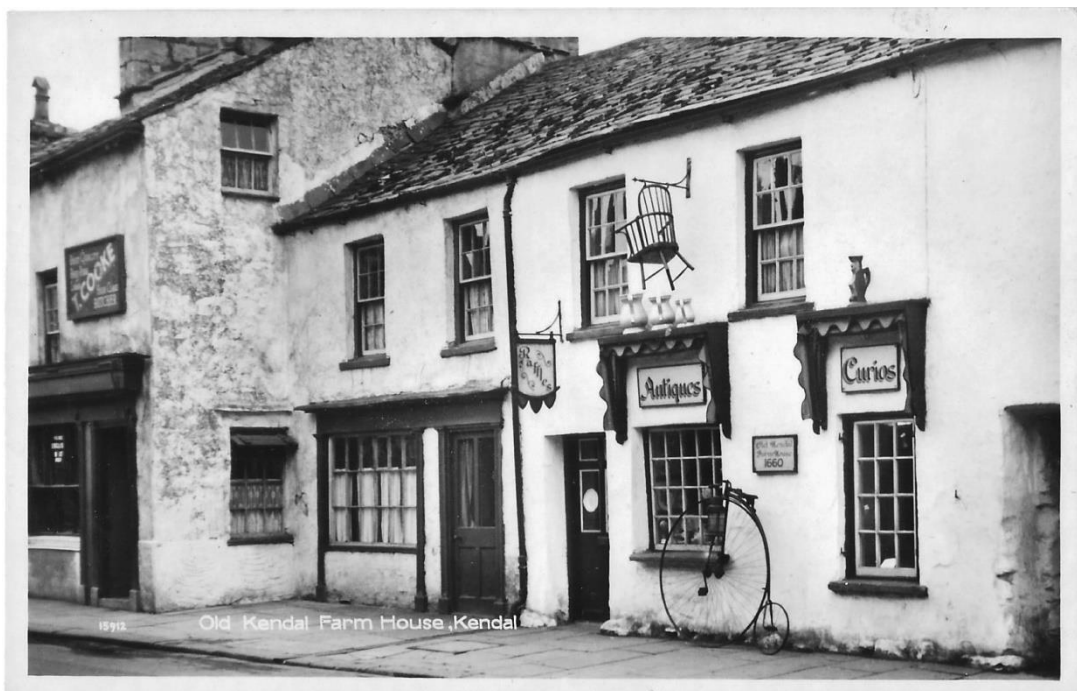
The postcard reproduced below (in the possession of the Aindow’s) shows the north elevation of ‘Sleddall Hall’ c1950. The premises was quite obviously being run as an antiques shop then too, but what is of particular note is that the walls are rendered with no drip moulds and the window over the ginnel blocked. Other details are worth noting, the postcard is titled ‘Old Kendal Farm House’ not ‘Sleddall Hall’ while T. Cooke’s butcher shop to the left is somewhat different in layout to that existing now, this being the result of a major rebuild of the front in recent years by the Aindow’s; the interior of this shop (now called ‘The Elf’) has just undergone a complete refurbishment following Storm Desmond in December 2015. This refurbishment required the plaster was removed from the walls allowing inspection of previously hidden features that have a bearing upon the development of ‘Sleddall Hall’. The former connecting door between the properties was revealed along with another formerly giving access to the next property. Machined brick was found to have been used in the blocking of the latter, suggesting a late Victorian or Edwardian date, but that used in the fireplace lintels was handmade and more likely to be of Georgian date.

Plate24: Postcard of ‘Old Kendal Farm House’.

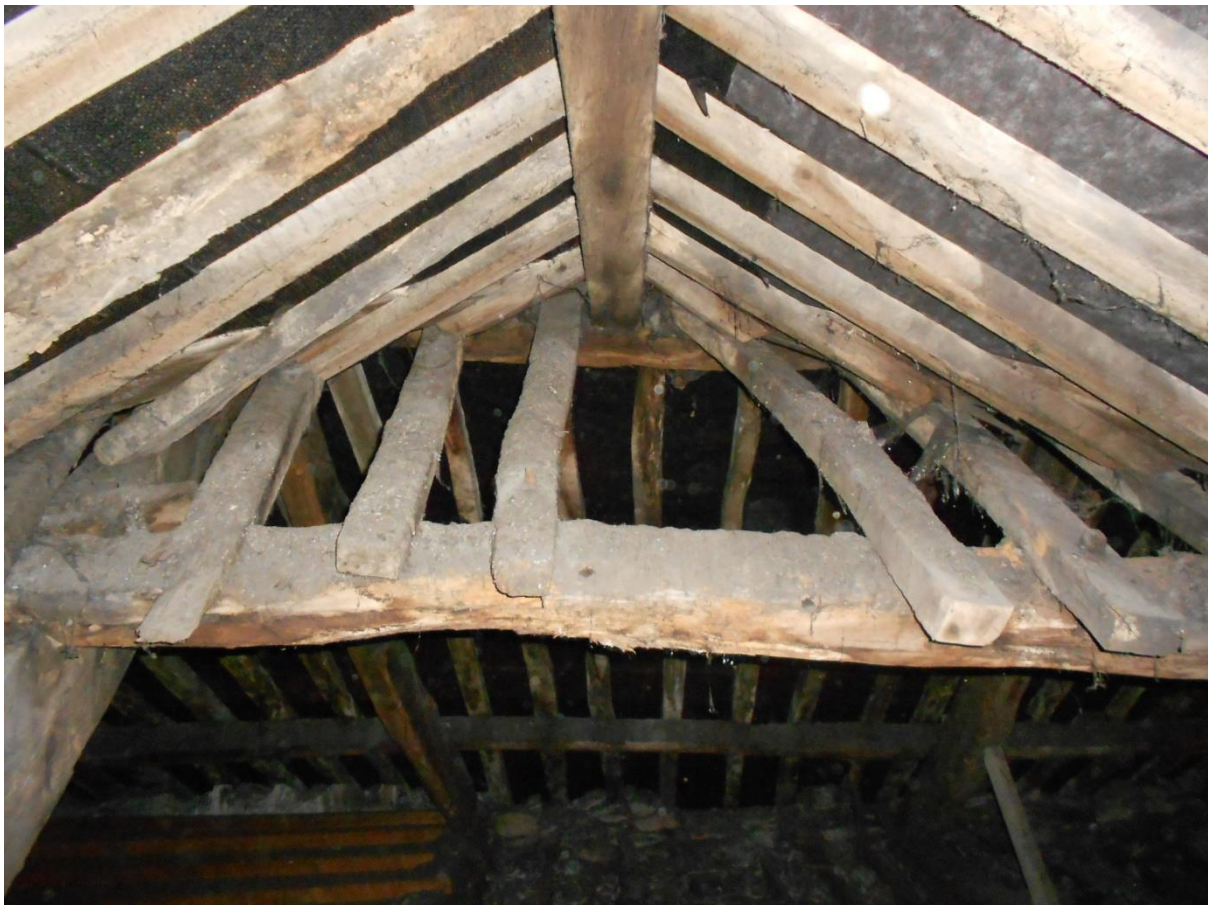
By c.1800, it would seem that the rear outshut (G5) had been raised to provide a second full height storey. This will account for the alterations to the roof of the north range, a section of the rear purlins being cut through and removed, along with the rafters, and a new roof constructed to fill the space, linking it to the south range (plate 25 below). The rear wall-head was extended upwards to form a gabled dividing wall which in turn gave support to the new roof over (F4) and eliminated the need for a second truss, but also provided access via an opening between the lofts. It's this phase that brings the two ranges together under one roof, giving us basically the footprint and profile that we see now.

Plate25: The inserted connecting roof between the north and south ranges showing the cut off rafters.

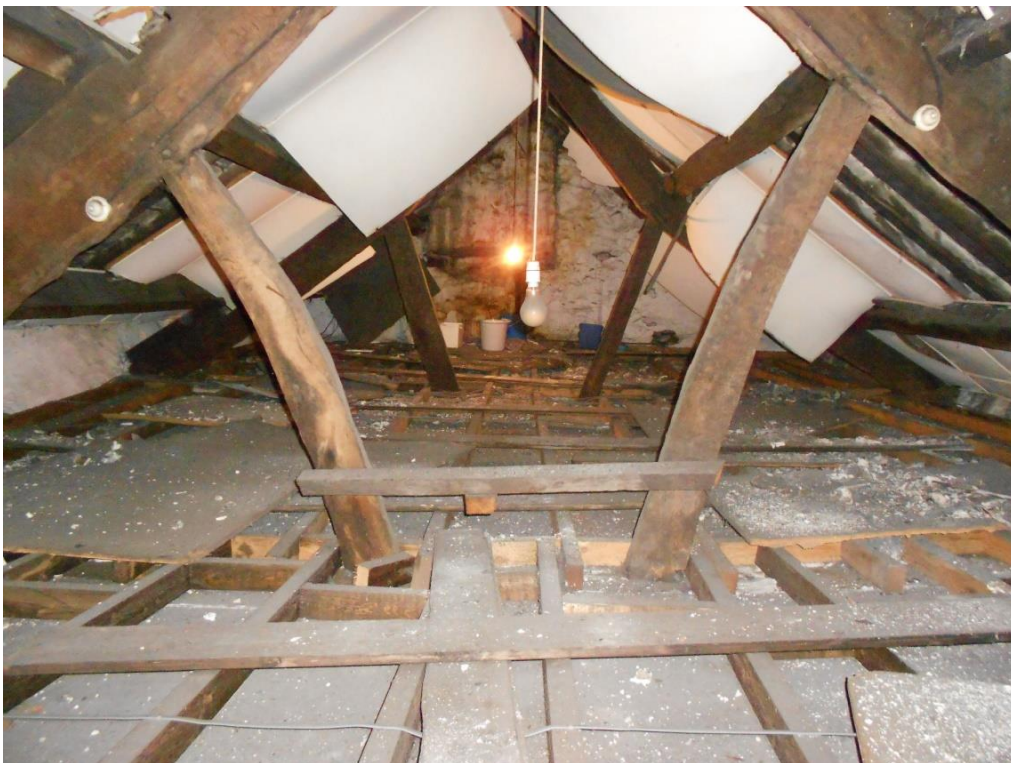
Plate 27. The main loft over F5 looking north. Note the tie braces and relocated purlins.

What seems to be apparent is that the form of timber roof construction in the south lofts above F5 and F4 is earlier than that in the north loft. The use of curved braces, large treenails pegging the timbers together and of course the cruck blades, all give a feeling of antiquity. But we shouldn't be misled into thinking it as straight forward as that, archaic styles and techniques lingered long in this part of the world!
