‘Sleddall Hall’ Wildman Street, Kendal.

Cumbria Vernacular Buildings Group (CVBG)

A survey undertaken by Clive Bowd & Mark Basey-Fisher 2015

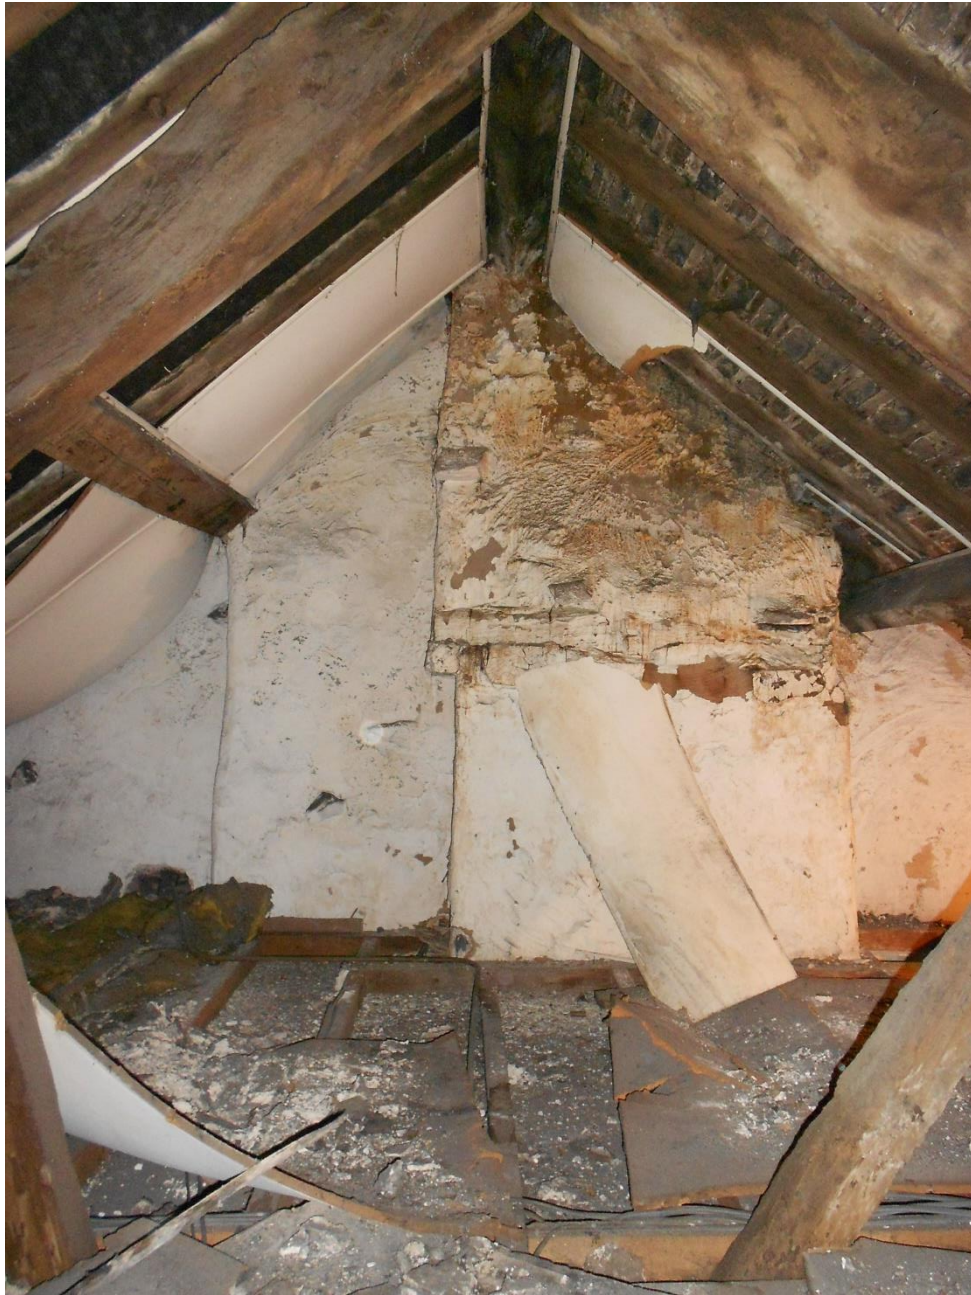
Plate28. The added and extended chimney stack over F4 clearly showing the timber corbelling. Note the earlier chimney stack behind, the braced truss in the foreground and the torching to the underside of the roof slates on the right. Also worth noting is the modern ceiling serving the room below, both in this loft and that shown above.

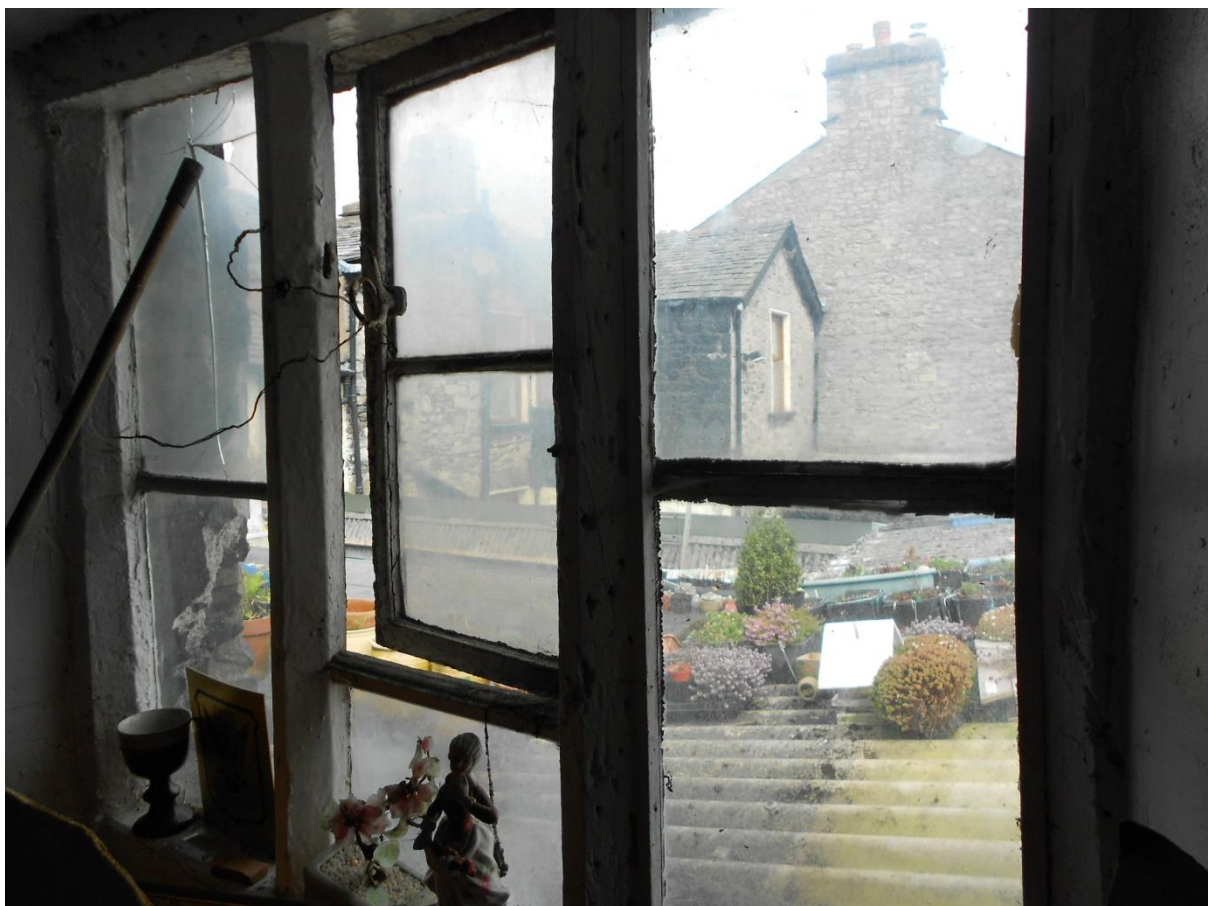
Plate29. Timber mullioned window in F5 with iron framed insert exhibiting iron fittings.

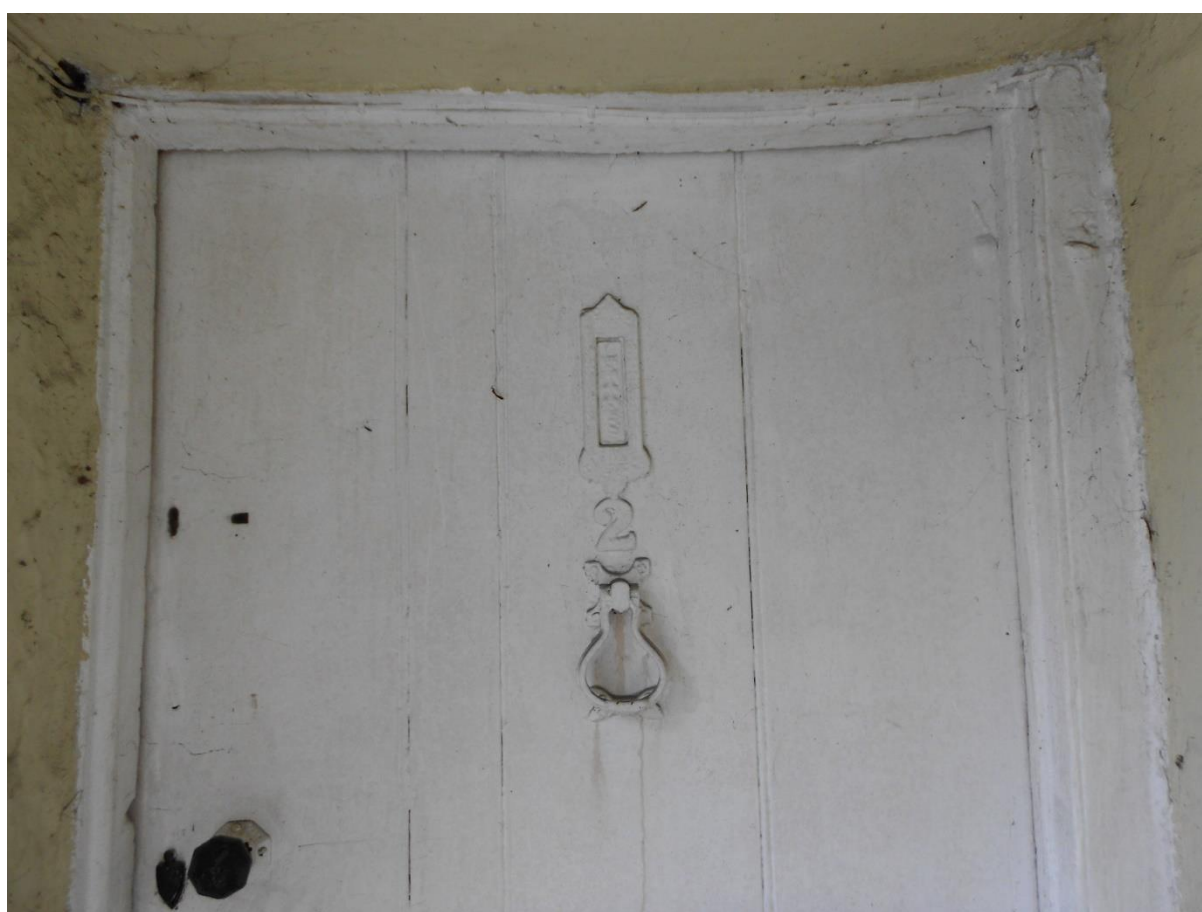
Plate30.Mid nineteenth century door furniture on unit 2.

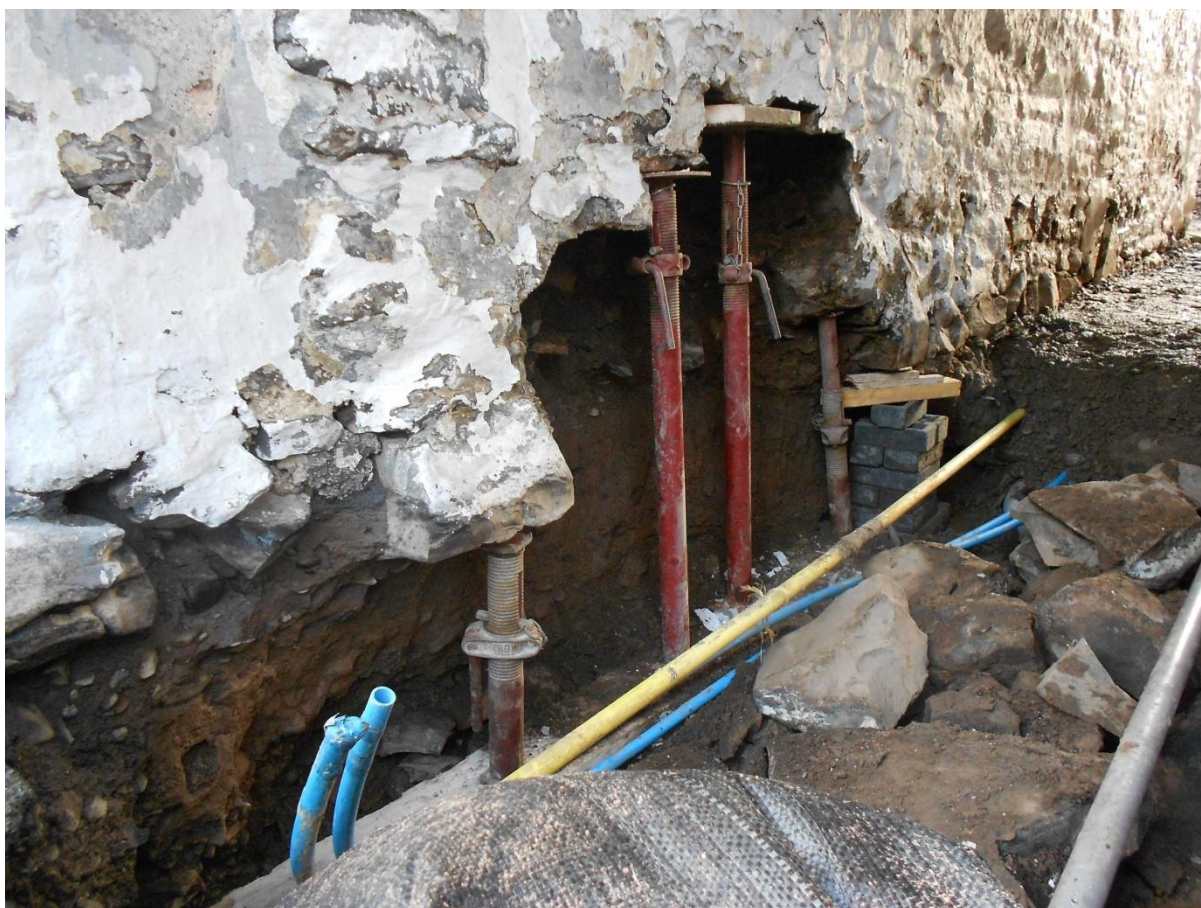
Storm Desmond in December 2015 was to play an important part in the history of ‘Sleddall Hall’. The damage caused by this flooding event brought home the risks that our built heritage faces from natural disasters, but it also highlighted the underlying strengths of the construction methods and materials used in such buildings. Failure of the hard-surfacing in the ginnel was not down to its makeup, but more to do with having been disturbed on previous occasions in laying services. In washing out and excavating the ginnel the footings of the north range were undermined revealing the construction of the walls (see plate 10 below). These walls stand on next to no foundations other than large stones being bedded in the underlying glacial till. Some partial collapse did occur, but little movement. This structural integrity is due in no small part to the inner and outer faces of the random rubble stone walls being filled with coarse stones and lime mortar, the latter providing not only cohesiveness throughout, but acting as a form of shock absorber enabling any movement to be absorbed, fractures to knit back together. A positive aspect of this flood event is that in the aftermath areas within the property have now become better accessible e.g. G4, G5 and G8, and previously hidden features can now be seen such as the stone flagged floors which had been covered in carpet, the suspended floor in G1 and the fireplace in G4. Another positive outcome of the flooding is that reappraisal of the use of the rooms has led to changes being implemented which will open up more of the property to the public. This can only be good for business, those interested in the local heritage, and the building itself.

Plate 31. Flood damage in the ginnel caused by Storm Desmond. Note the lack of footings!
